Wairarapa Peer Review 2006/07

August 2007

This year's inspection visited sites on two schemes; the Lower Wairarapa Valley Development Scheme and the Waiohine River Scheme.

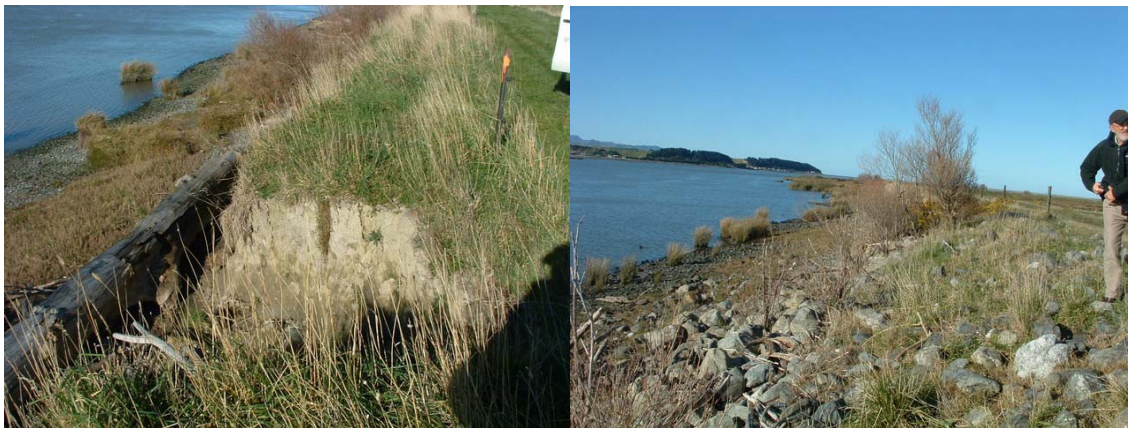
The Onoke stopbanks border the lower reaches of the Ruamahanga River and Lake Onoke. The stopbanks were constructed in 1964 from dredged riverbed material, their location means they are subject to both tidal action and wind generated wave lap that has resulted in substantial damage to the riverside stopbank face. In areas, large holes are affecting the integrity of the stopbank, which is further exacerbated by river borne debris.

Picture 1: erosion 'hole' (left); repaired stopbank (right)

- Filling and shaping of the effected locations to achieve a natural batter slope.
- Reinforcement of the stopbank face with $d_{50}100$ mm gravel material; applicable to those stopbanks with a condition rating of 1 or 2.
- Planting of the riverside berm with native shrubs; applicable to those stopbanks with a condition rating of 3 or 4.

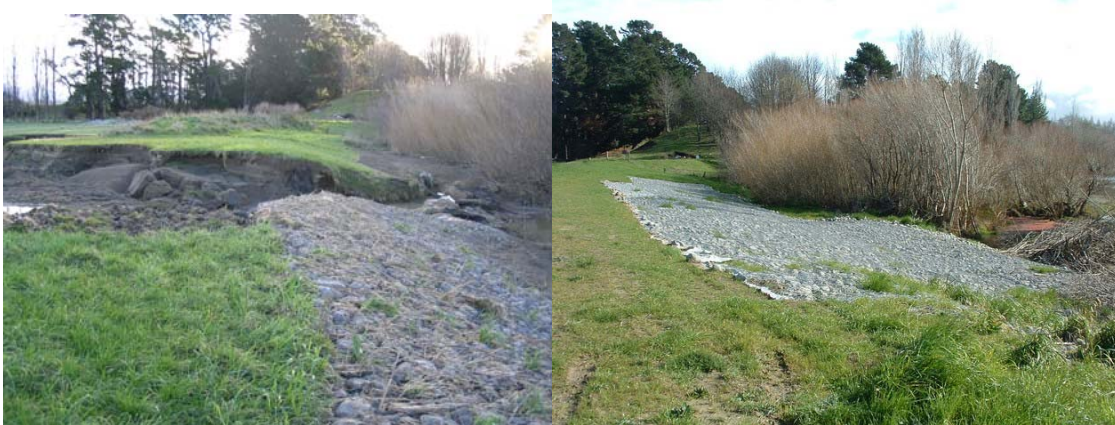
The duckbill drop structure essentially consists of three main components, a large grassed area that surrounds the actual drop structure, the Reno mattress drop structure, and shrub willows immediately adjacent to the channel. Due to the sandy nature of the soil, the 'duckbill' is prone to erosion. During the July 2006 flood event, a large erosion embayment (shown in **appendix 2**) developed at the downstream end of the left bank

Picture 2: damaged 'Duckbill' drop structure (left) and the repaired structure (right).

The reviewers consider that the approach taken, in terms of temporary and permanent works, was appropriate. It was noted that the structure performed extremely well given the duration that the floodways system was in operation. The reviewers' endorse the development of the wetland area immediately behind the low level stopbank.

Reno mattress protection. As the damage occurred during a period of wet weather a temporary repair of filter cloth and rock was constructed. Permanent works, which continued the existing Reno mattress protection (shown in **appendix 2**) and included the construction of a low level stopbank, were completed in March 2007 and the end result is shown below in picture 2.

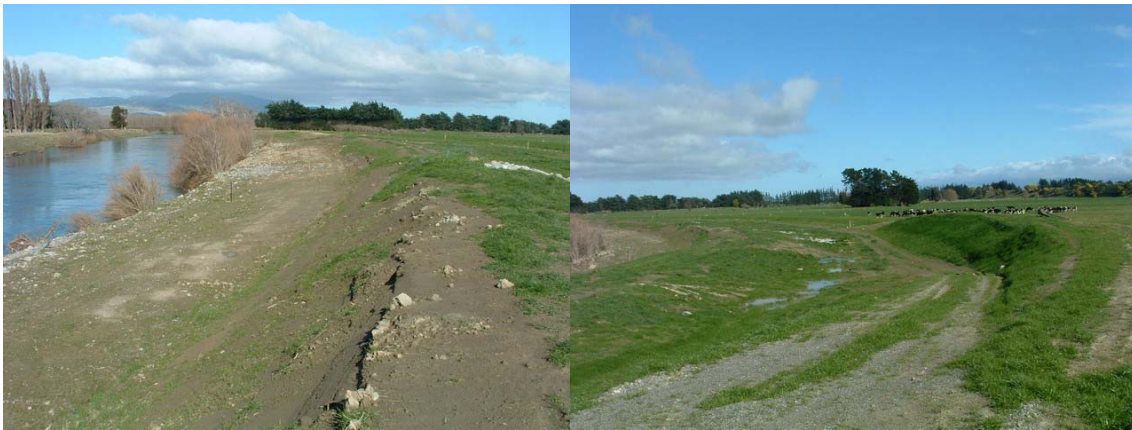
Significant scour damage to the downstream face of the sill occurred during the July 2006 flood event (shown in **appendix 3**); exacerbating the initial damage that occurred in February 2004. As for the 'duckbill' drop structure, the damage to the sill occurred during a period of wet weather necessitating the scour holes to be filled with large boulders until a permanent works could be constructed.

Picture 3: riverside berm to be lowered (left); extended stopbank and realigned sill (right)

The reviewers were impressed with the scheme manager taking the opportunity to construct sustainable permanent works rather than to continually patch the sill. It is imperative that the second stage of the works (the construction of the debris fences) occurs as soon as is practicable as the sill in its present condition is still very vulnerable.

- Extending the existing stopbank.
- Rebuilding the sill on a new alignment, inland and towards the south.
- Reinforcing the upstream half of the sill structure with enkamat (an erosion protection mat) to allow for overflow velocities.
- Lowering the riverside berm to reduce slumping of the bank.
- Constructing 4 debris fences on the lowered berm (to be constructed this construction season); the fences will be designed to pass small debris, and to deflect rather than capture large debris.
- Strengthening the bank edge with the rock used in the temporary repair works and the buffer zone by willow planting.
