On the beaches

Recreational water quality monitoring
results for the 2013/14 summer

Morar, S and Greenfield, S. 2014. *On the Beaches: Recreational water quality monitoring results for the 2013/14 summer*. Greater Wellington Regional Council, Publication No. GW/ESCI-T-14/63, Wellington.

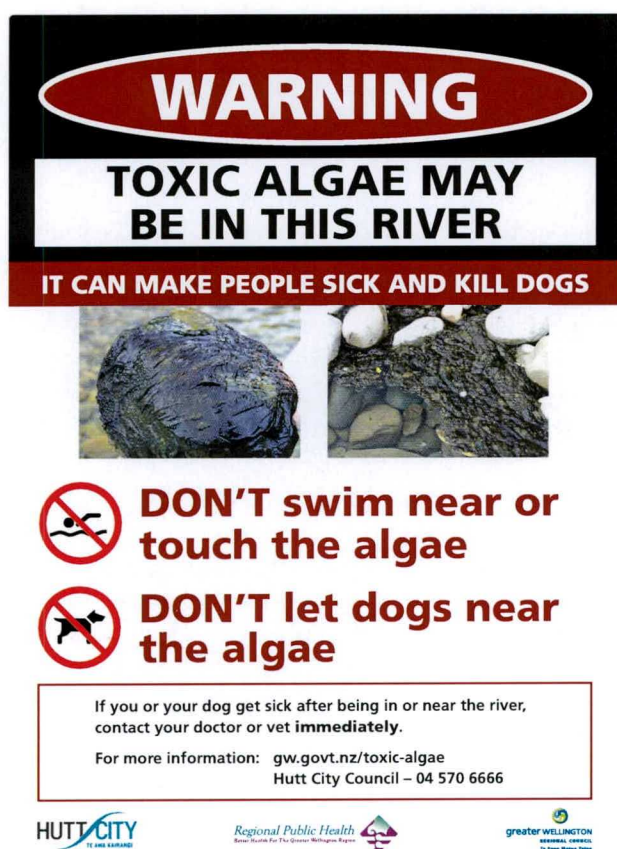
Figure 3.2: Warning sign used to inform the public of the health risk from cyanobacteria in rivers in the Wellington region

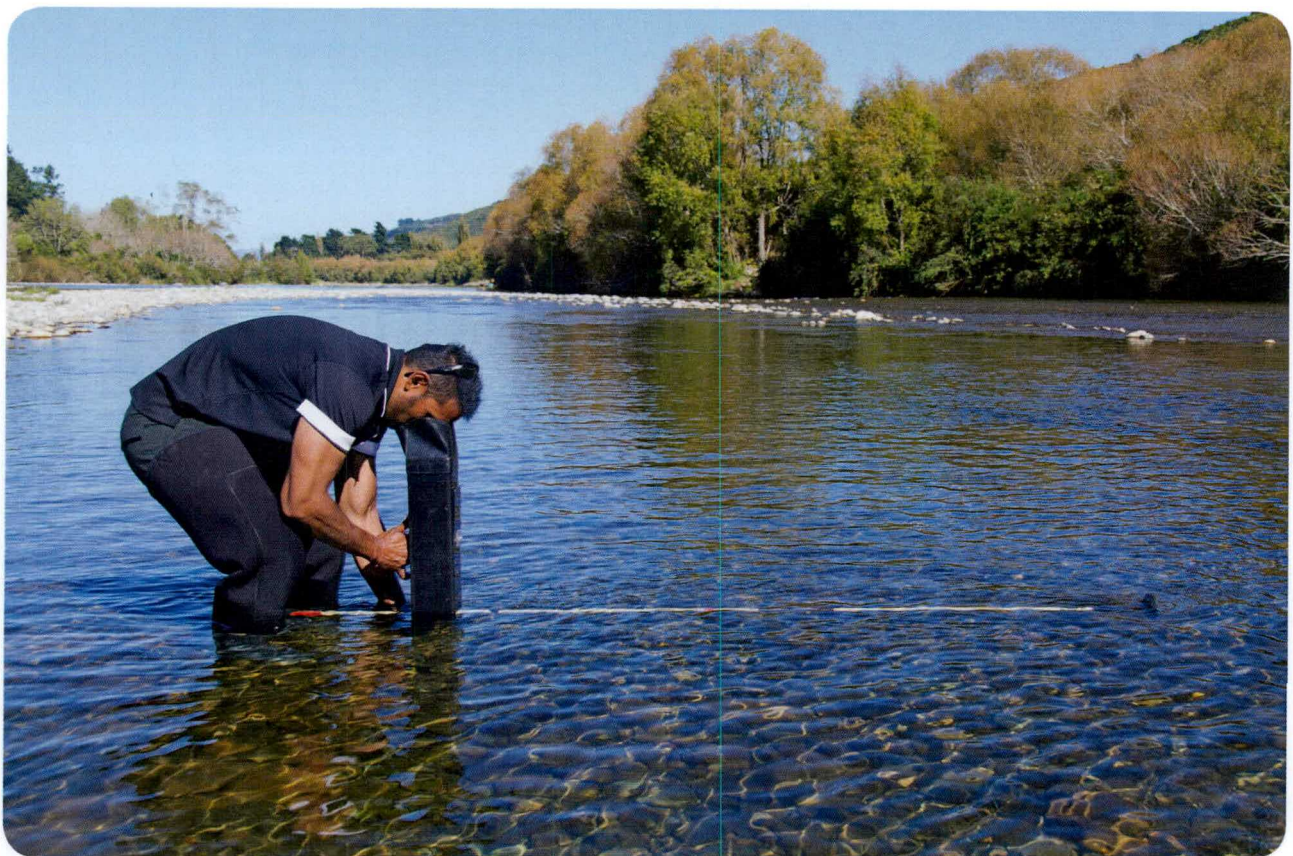
An assessment of water clarity on the Hutt River at Silverstream. A black disc fixed at 1.6 m from the viewer is used to assess whether the water clarity guideline is being met

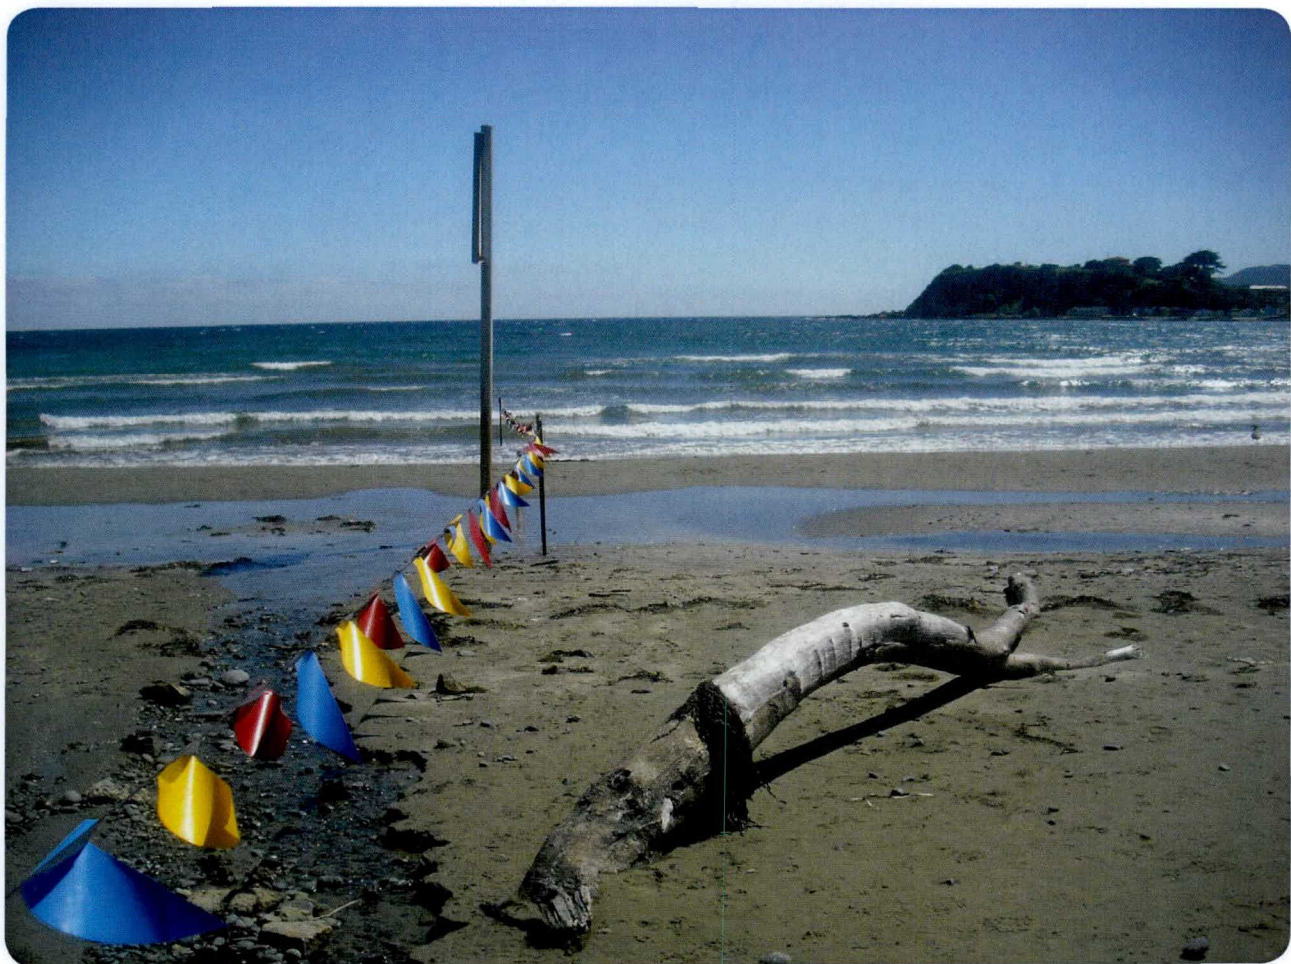
Titahi Bay at South Beach Access Road. Very high levels of human faecal contamination were identified in the small stream that discharges at this site. Investigations into sewer and stormwater infrastructure are ongoing

The only sample from Titahi Bay at South Beach Access Road with a high enterococci count during the investigation period was taken on 4 February. PCR marker analysis of this sample identified wildfowl as the source of contamination. High *E. coli* counts (1,620–18,000 cfu/100mL) were recorded in all but one of the eight samples collected from the piped stream in the vicinity of the South Beach Access Road site. However, as a very high level of human faecal contamination was identified at this site during investigations undertaken in 2013, no further analysis of these samples was undertaken. Since 2013, Porirua City Council have found a number of illegal sewage discharges to the stream and are continuing to investigate sewer and stormwater infrastructure in the area (Joanna Saywell¹⁴ pers. comm.). A public health warning sign remains in place at the site.
