Island Bay Five Year Restoration Plan

Prepared for Wellington City Council and Greater Wellington

June 30th 2009

Report Number: CCERL/R27-28/01/2009

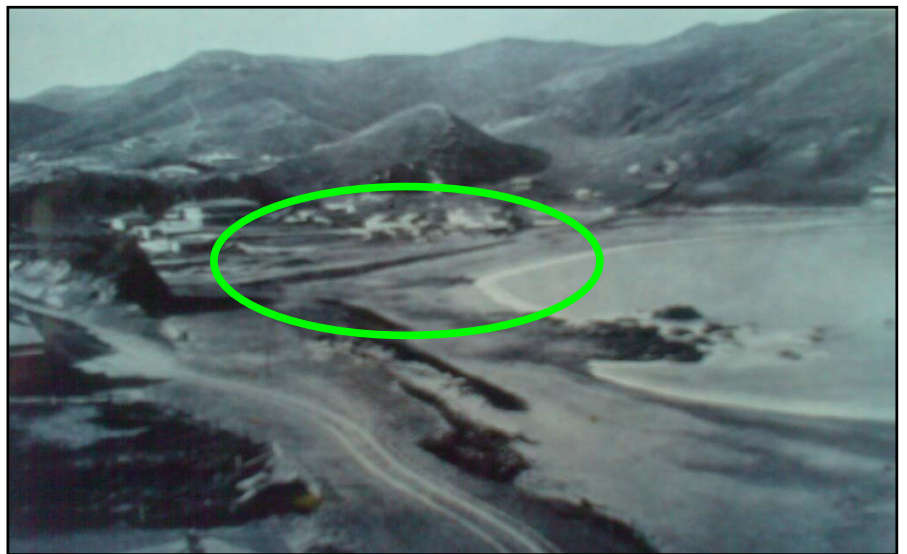
Figure 1: View of Island Bay around 1900. The beach in the foreground clearly has significant dunes covered in dune vegetation. The straight alignment of the road (circled) appears to cross the beach in the area where dunes previously existed (photograph Marie O'Hagan).

Even the earliest photographs show how the development of the Island Bay township has dramatically altered the beach from its' original state (see Figure 1). Other historical photographs clearly show that the beach originally comprised a large sand dune system that was extensively covered in native sand binding grasses.

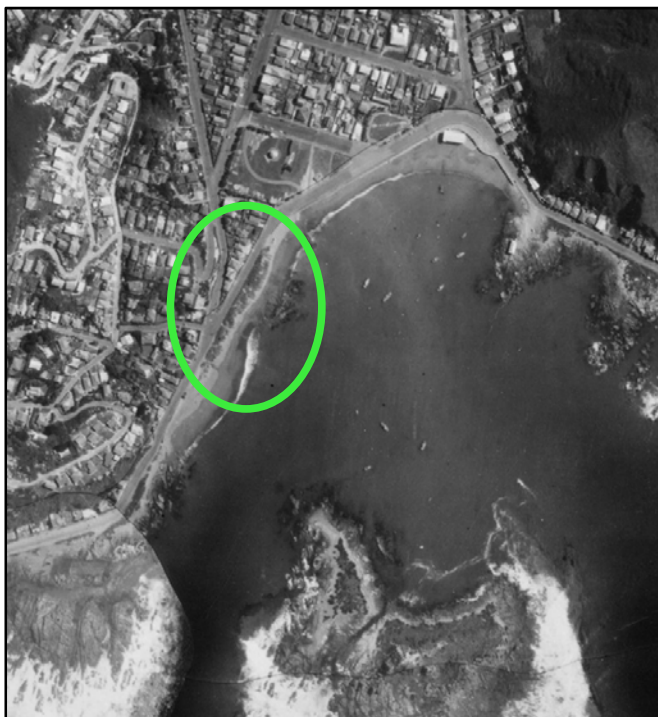
Figure 2: Aerial view of Island Bay in 1962. Note the large area of dune vegetation at the western end of the beach (circled) is only a narrow remnant of foredune and vegetation cover evident in earlier historical photographs (photograph WCC archives).

A substantial area of native dune vegetation at the eastern end of the beach was still visible up until the 1930s in historical photographs. By the 1960s, this had disappeared and, at the western end, the dune vegetation had been reduced to only a narrow band (see Figure 2).

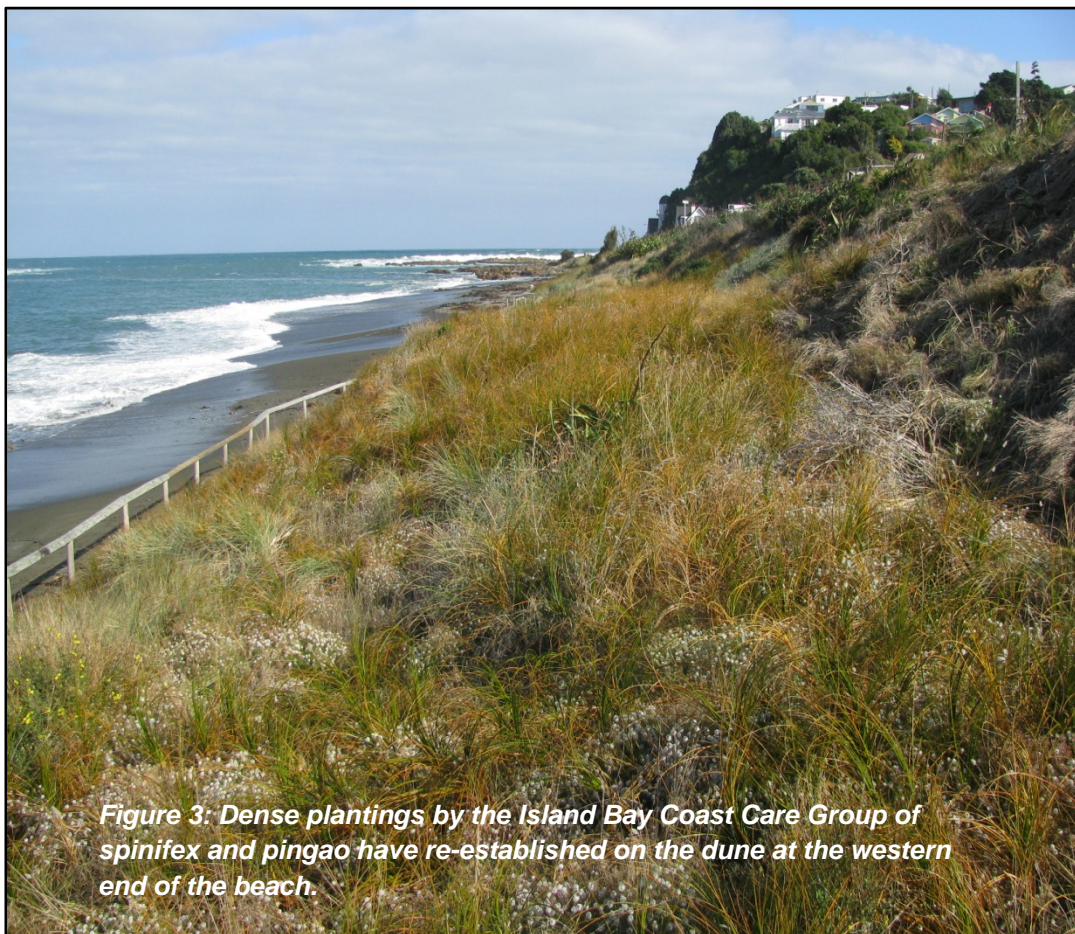
Figure 3: Dense plantings by the Island Bay Coast Care Group of spinifex and pingao have re-established on the dune at the western end of the beach.

- Planting and management of spinifex and pingao on the steep seaward face of the foredune over the last few years has built a significant incipient dune. This has resulted in vigorous colonies of both species on the foredune extending several metres beyond the fence established originally to protect plantings.

- Planted spinifex in particular along the mid-slope zone is thriving which suggests that this is still part of the active foredune and being fed with fresh sand from frequent strong winds.

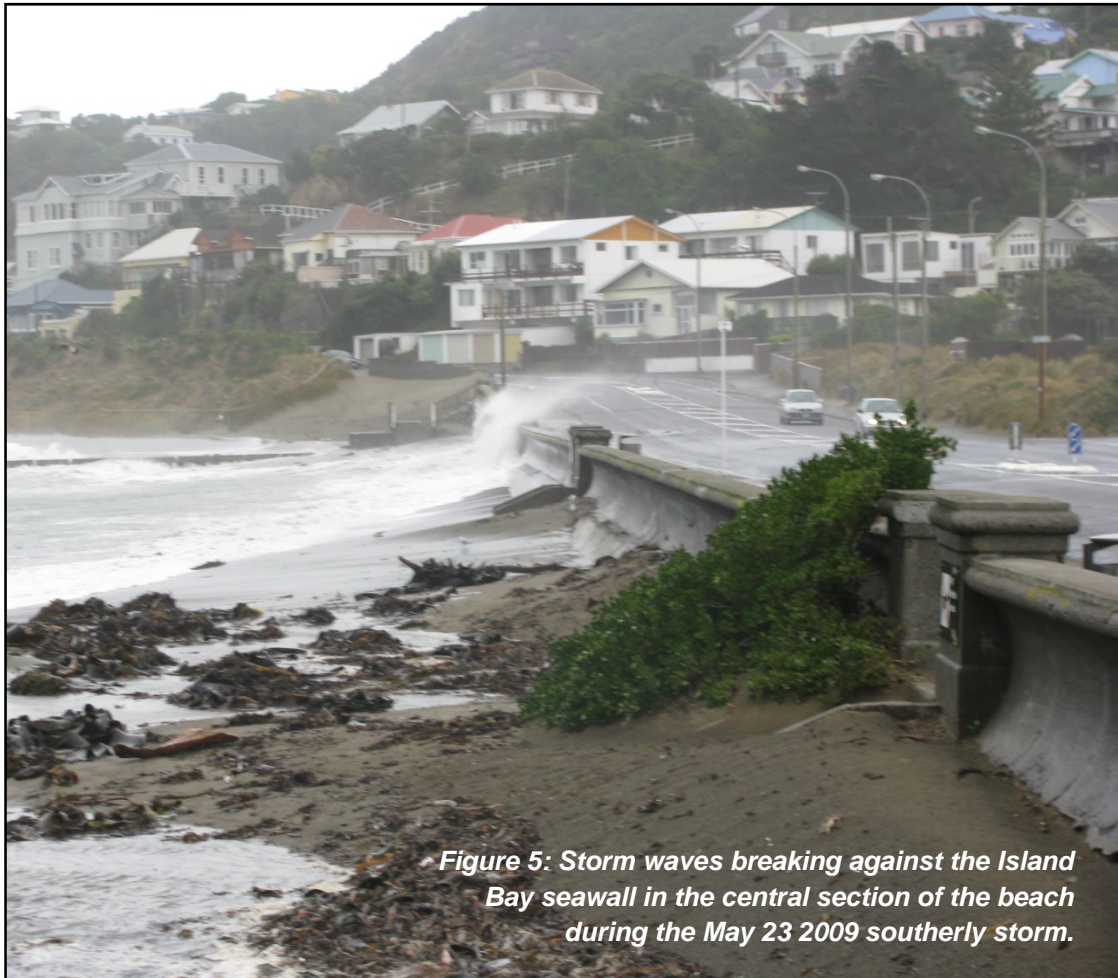
seawall in the central portion of the bay, in particular, cuts seaward across the natural curve of the beach. Establishing and maintaining a foredune seaward of the wall is likely to be very difficult. Waves regularly impact on the wall in the centre of the beach (see Figure 5) which will likely preclude the establishment of permanent dunes or dune vegetation in this area.

AREA C – CENTRAL BAY SEAWALL (FIGURE 5)

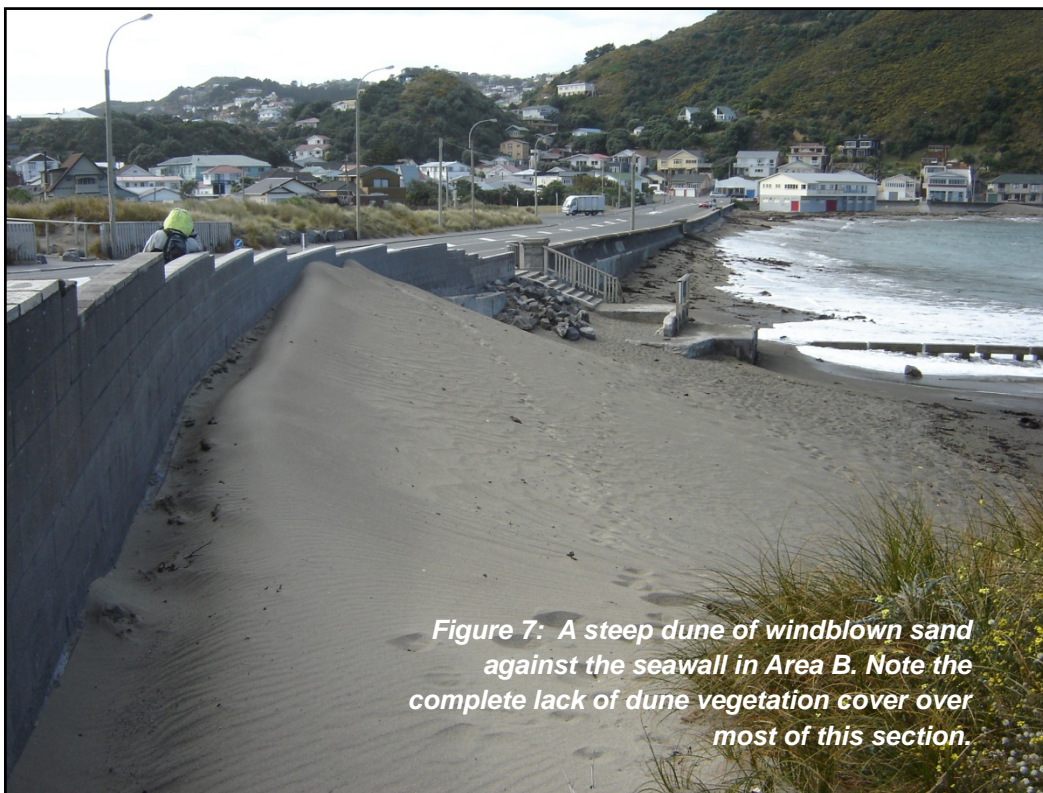
- Short area comprising a steep incipient dune of bare sand adjacent to the seawall between the western end of the seawall and the large concrete stormwater outfall.
- Access-ways occur at both ends of this area. The western access at the end of the seawall leads directly onto the bare sand allowing a steep descent onto the beach. The eastern access-way at the stormwater outlet is via concrete steps where sand is blowing onto the footpath through the gap in the seawall.
- The area is used by children for jumping onto bare soft sand. Discussions suggest that residents are not opposed to leaving all or part of this area as a play area although there is concern that concrete or rocks partially submerged under the sand could injure children jumping off the seawall.

- As indicated by residents, this relatively short area of free moving sand could be left as a sacrificial dune for children. However, the project team agree the blocks of concrete just below surface of sand could be a health and safety issue for those jumping off the wall depending on the fluctuating levels of the sand. WCC indicate that the blocks are part of the works associated with the road protection and their removal would compromise the integrity of the wall.

- Alternatively, in consultation with the local community and beach users, small areas could be fenced off progressively for planting with native sand-binders. Access-ways will require alignment to avoid wind funnelling sand onto the road, and guide fencing to protect any new plantings. There appeared to be no objection from across the Island Bay community to extending the sand binders over this area.

Within the five-year time frame, and with ongoing community consultation, planting using native sand binding plants could be expanded into Area B. This would cover the partially hidden concrete blocks adjacent to the wall that are potentially hazardous to children jumping off the wall into loose sand.

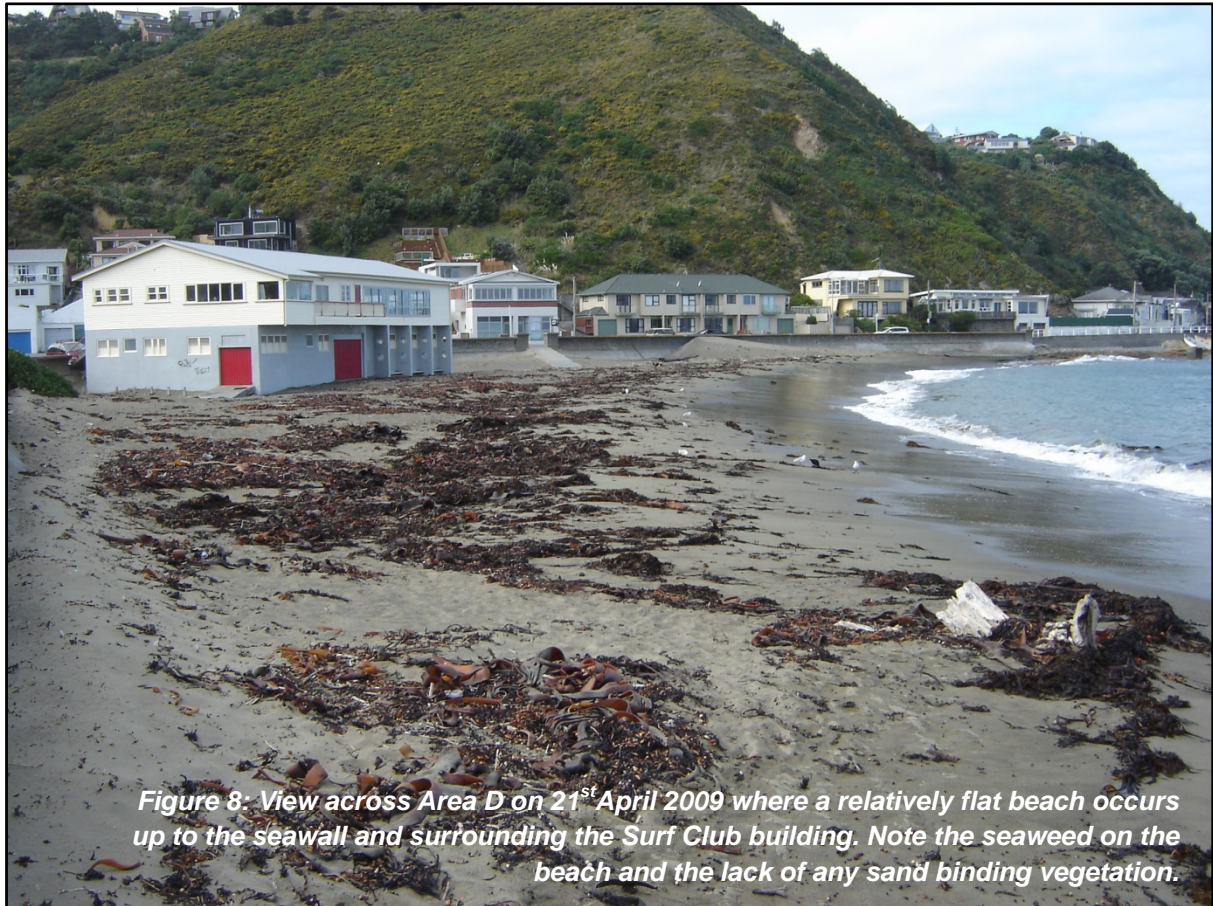
- This area is a low-lying flat beach to the seawall and surrounding the surf club building. Residents indicate that waves rarely reach the seawall along this area.
- Seaweed is deposited during and after southerly storms, principally kelp from nearby rocky shores and the near-shore islands.
- The surf club building is within the active foredune zone. Water inundates the dune areas around the building during occasional high seas and storms.
- There is evidence that sand is being funnelled onto the footpath in the vicinity of an access-way where there is a gap in the seawall.

A compromise is suggested for Area D, whereby the establishment of a small foredune immediately adjacent to the seawall is developed and maintained along with retaining an open beach at low tide available for recreation that has infrequent clearing of seaweed during summer months only. Planting of sand binders could precede based on the results of revegetation at the eastern end of the bay. This recommendation is dependent on, and requires, ongoing consultation with local residents and beach users.
