# On the beaches 2011/12

Annual recreational water quality monitoring report for the Wellington region

GW/ESCI-G-12/153

November 2012

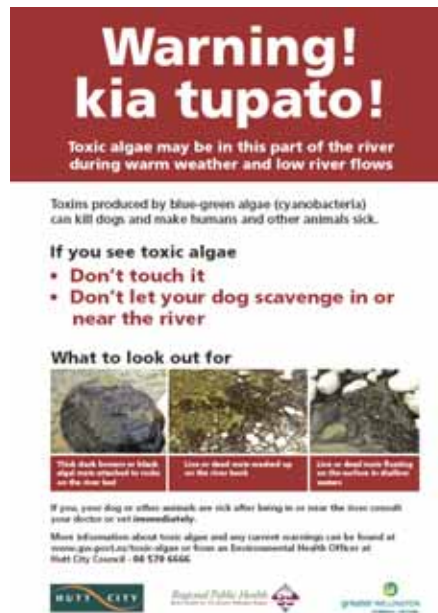
**Figure 3.2: Warning sign used to inform the public of the health risk from cyanobacterial mats in rivers in the Wellington region during the 2011/12 bathing season**

In 2009, interim New Zealand guidelines for cyanobacteria in recreational lakes and rivers were released (MfE/MoH 2009) for trial by monitoring and health agencies<sup>7</sup>. The interim guidelines for rivers identify a three-tiered alert level framework for benthic cyanobacteria (Table 3.3). The warning sign used to advise the public of the risk from benthic cyanobacteria is shown in Figure 3.2.

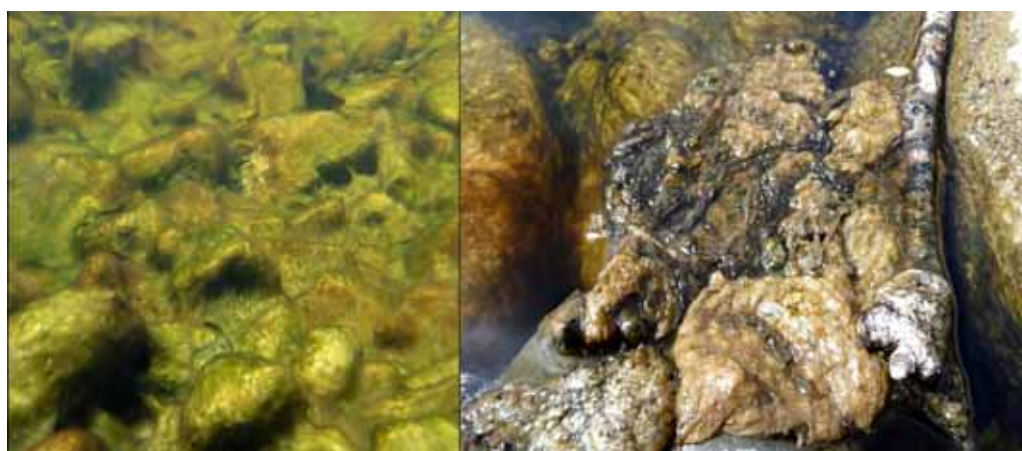
**Figure 3.4: Potentially toxic mats of *Phormidium* sp. growing on the river bed (left) and dislodged on the river's edge (right) at Hutt River at Birchville on 21 February 2012**
