# Is it safe to swim?

Recreational water quality monitoring  
results for 2016/17

Brasell KA and Morar SR. 2017. Is it safe to swim? Recreational water quality monitoring results for 2016/17. Greater Wellington Regional Council, Publication No. GW/ESCI-T-17/98, Wellington.

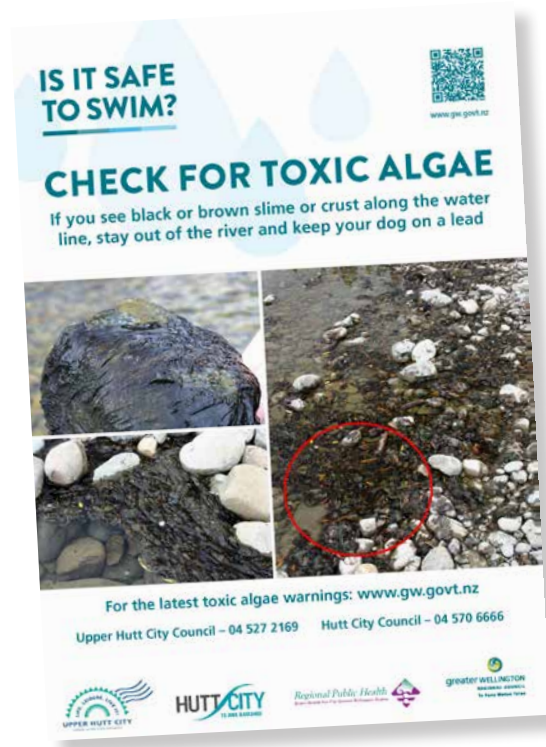
**Figure 3.2: Sign used to inform the public of the health risk from cyanobacteria in rivers in the Wellington region**

In the Wellington region, the response to toxic algal blooms in rivers is managed by a working party of Regional Public Health, Territorial Authority and GWRC staff. Close monitoring of 'flushing' river flows <sup>(6)</sup> and the potential for occurrence of cyanobacterial blooms is a critical part of this process. Warnings based on latest weekly results are displayed on <http://www.gw.govt.nz/is-it-safe-to-swim/>. The information sign used to advise the public of the risk from benthic cyanobacteria is shown in Figure 3.2.

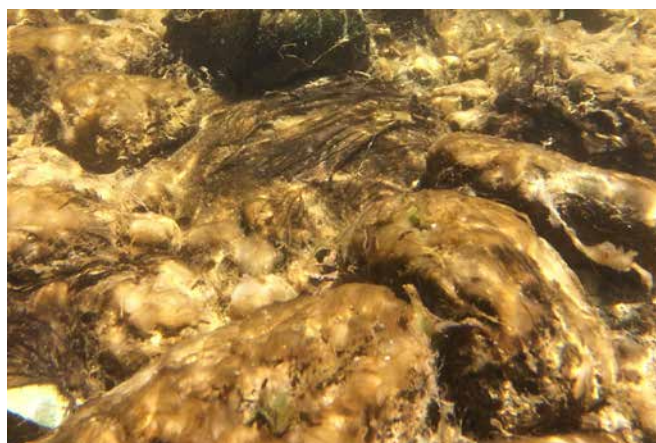
**Diatom (light brown) and cyanobacteria (dark brown) mats growing simultaneously on the river bed of the Waipoua River at Colombo Road on 22 December 2016**

The Waipoua River at Colombo Road was also the only site to breach the alert level of the MfE/MoH (2009) interim cyanobacteria guidelines (>20% coverage). Microscope analysis of the mat material showed that the diatom *Cymbella* was the dominant species, but a precautionary amber alert was triggered because the potentially toxic cyanobacteria *Phormidium* was also present in sparse but dense patches and mats had started to detach from rocks. This occurred on just two occasions (13 and 19 December 2016), following a prolonged low flow period in the Waipoua River catchment where a large flushing flow occurred on 27 November, followed by at least 22 days without another significant flushing flow to remove the periphyton mats. Despite no flushing flows occurring until late January 2017, cyanobacteria growth subsided to less than 5% coverage within two weeks of the last exceedance. A very small amount of detached mats were associated with these exceedances but there were no known related incidences of human or animal illness. GWRC and territorial authorities issued a media release on 19 December and Masterton District Council posted toxic algae information signs at key access points along the Waipoua River. There were no action level (>50% cover) guideline breaches this season.
