## Chapter Two

# SETTLEMENT, STAGNATION AND GROWTH

## 1840 - 1899

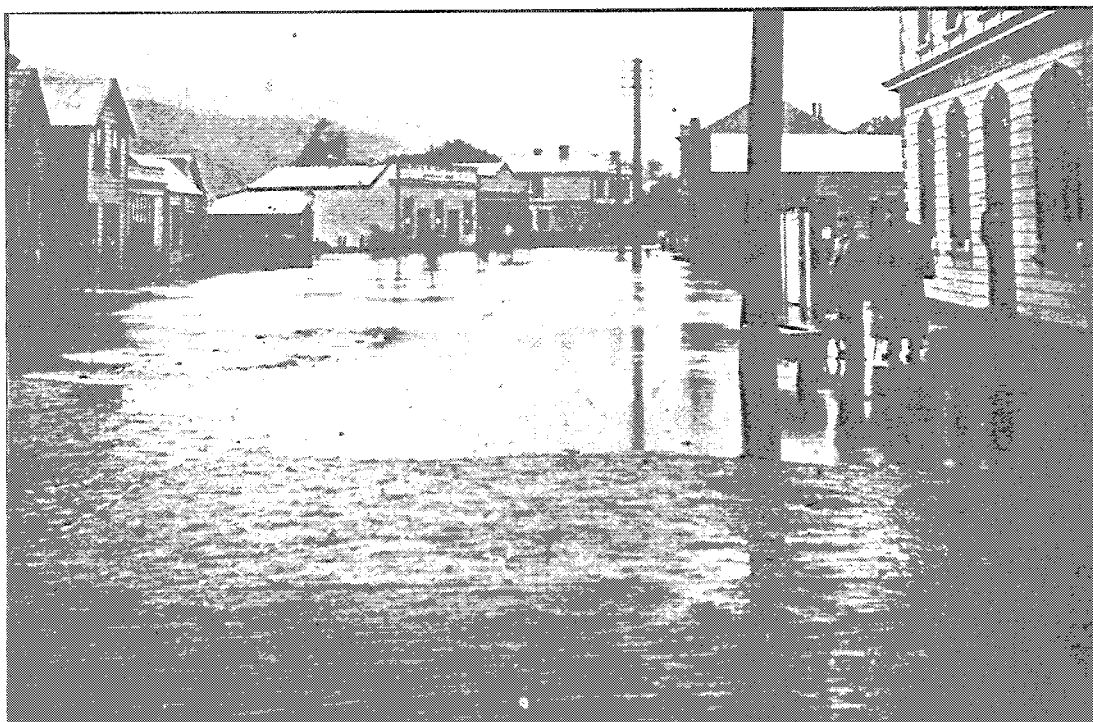
**Plate 25: High Street, Lower Hutt, 1904.** Source: From a "newspaper cutting", neg. held by the War Memorial Library, Hutt City.

Plate 25 shows the flood waters receding after the 1904 flood, a relatively small event probably a quarter of the volume of the 1898 floods. By 1904 the stopbank construction on the eastern bank was largely complete, however, a portion of the works had been postponed pending the construction of the replacement Hutt Bridge. In the previous "old man" floods High Street had been submerged by up to 1.2 m and was left rutted and scoured.
