Te Awarua-o-Porirua Harbour
Sediment Plate Monitoring
2022/2023

Prepared for
Greater Wellington Regional Council
July 2023

Salt Ecology
Report 118

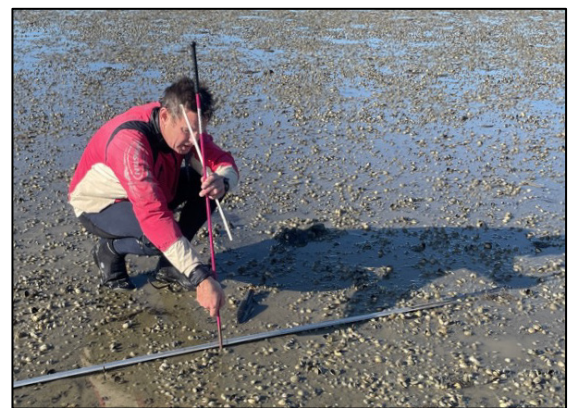
Mud deposits on the Porirua Stream delta, January 2023.

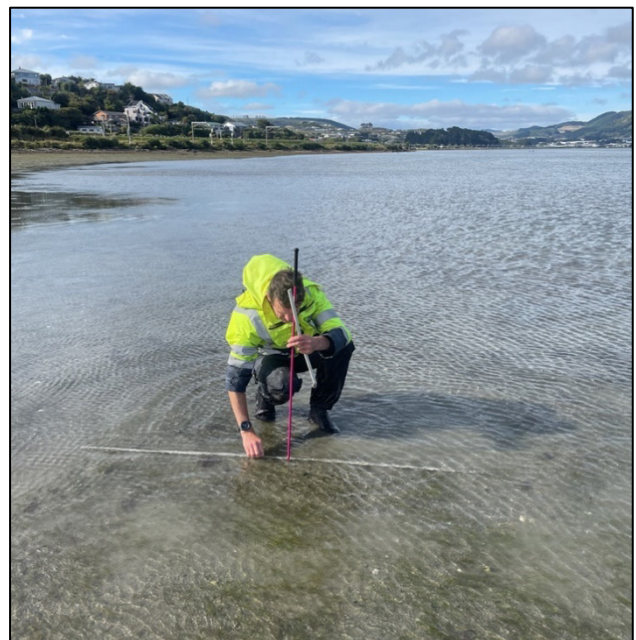
Measuring sedimentation at Site 1 (Onep A), Onepoto Inlet.

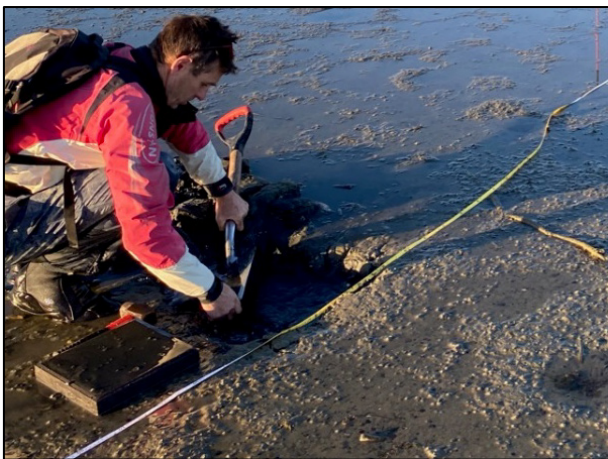
Installation of plates at site Onep B, Onepoto Inlet.

To date, 35 concrete 'sediment plates' (19cm x 23cm paving stones) have been buried at 9 intertidal sites, and 9 concrete plates (30cm diameter circular pavers) have been buried at 9 subtidal sites in the estuary (Fig. 1). Each plate has been placed in stable substrate 5-30cm beneath the sediment surface, with sites positioned to assess the dominant sediment sources to the estuary. These include discharges of bedload and suspended sediment from the various streams, most notably Pāuatahanui, Horokiri, Porirua, Kakaho and Duck Creek (see Green et al. 2015, also Fig. 1).

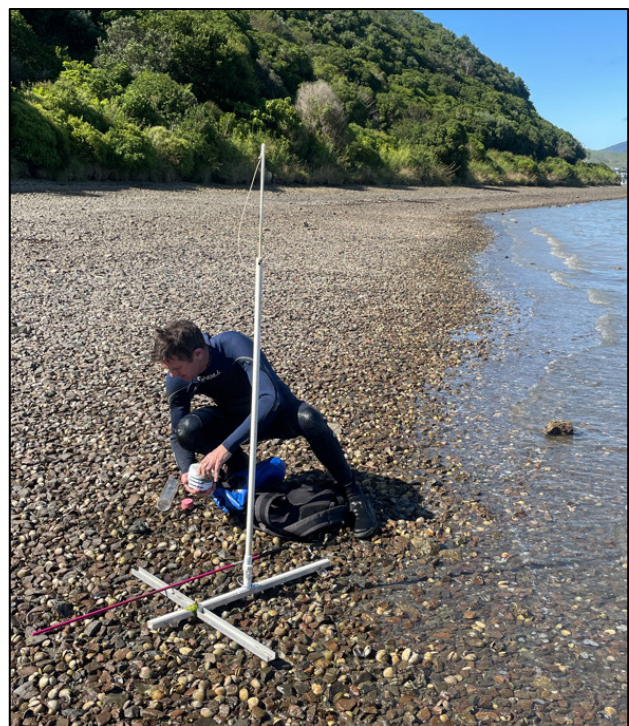
Subtidal plate depths were measured using a custom-built frame (see photos on the following page). The frame was positioned $\sim 5\text{cm}$ above the sediment overlying each relocated plate and allowed to settle onto the surface sediment. A measuring rod was then pushed down through a vertical tube to the underlying plate. Sediment depth is the distance between the base of the frame and the buried plate.

Frame used to measure subtidal plates at the water surface.

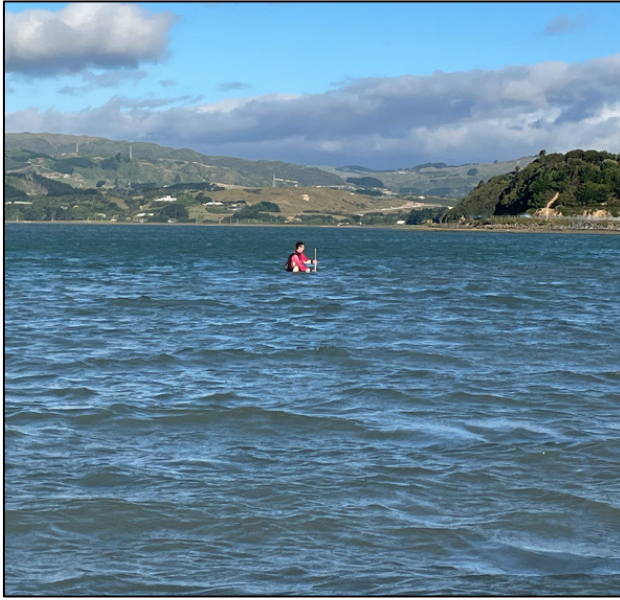
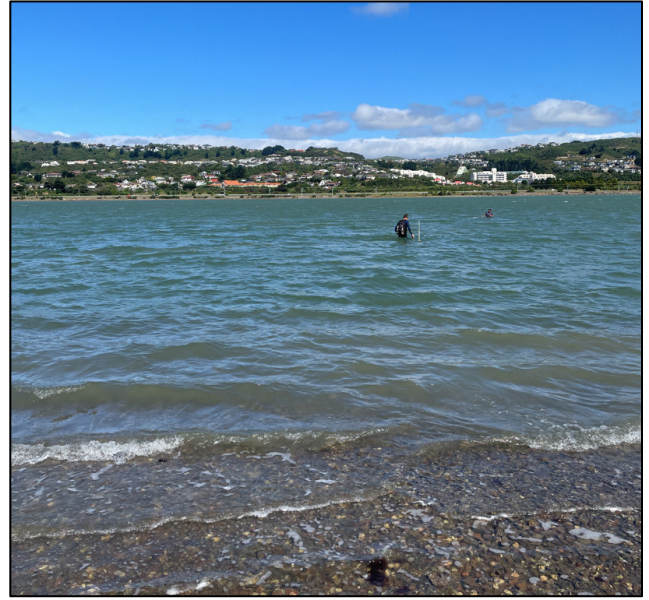
Measuring subtidal plates in the Pāuatahanui Inlet (Site PS3 – Browns Bay) and at Onepoto Inlet (Site OS9).

The measurement is taken above the water surface using marked increments on the measuring rod. To collect three replicate measures at each plate, the frame was repositioned twice more by carefully lifting, rotating 30° clockwise, and allowing it to resettle. An inflatable boat or kayak is used to reach some subtidal sites.

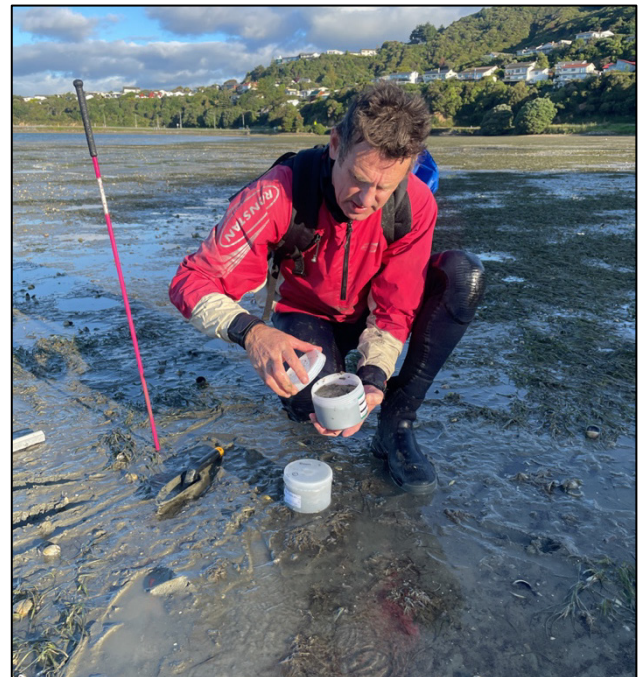
Collecting sediment samples for laboratory analysis, Browns Bay intertidal Site P11, Pāuatahanui Inlet.

A sample of the surface 20mm of sediment is collected adjacent to each sediment plate and combined to make one composite sample per sediment plate site. The sample is analysed for particle grain size (wet sieve, Hill Labs; Appendix 1). This approach allows changes in sediment muddiness to be determined even where there are no changes in sediment depth. Results are compared to condition bands (Table 1) described in Section 2.4.

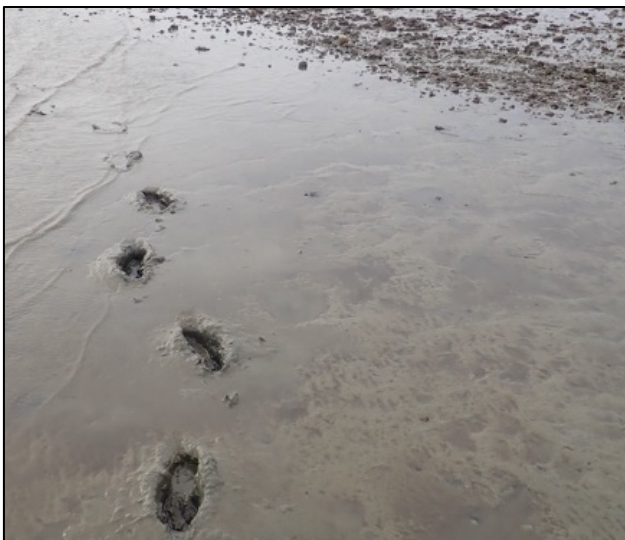
The muddiest and deepest deposits of intertidal fine sediments remaining in the harbour were located near Ration Point where ankle deep muds were overlying gravel beds in many areas near the low tide line (see photo below).

Soft muds overlying gravelbeds on the intertidal flats near Horokiri (PS2), Pāuatahanui Inlet, January 2023.

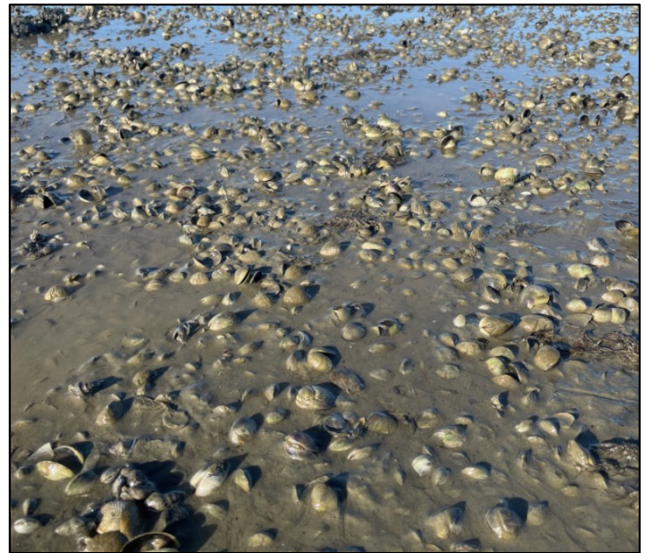
On the Porirua Stream delta, cockle beds were covered by muds that appeared to have been recently deposited.

Over the previous 12 months, sediment depths in this part of the Onepoto Inlet had increased by 17.2mm at site O2 (see photo below), and 12mm at O3.

Muds deposited on cockle beds at the mouth of the Porirua Stream (O2), Onepoto Inlet, January 2023.

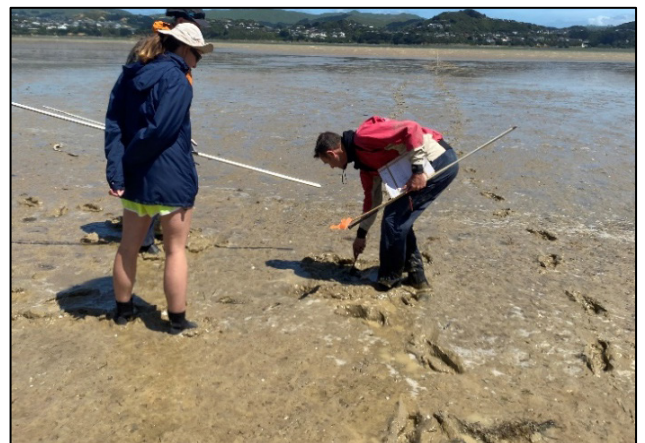
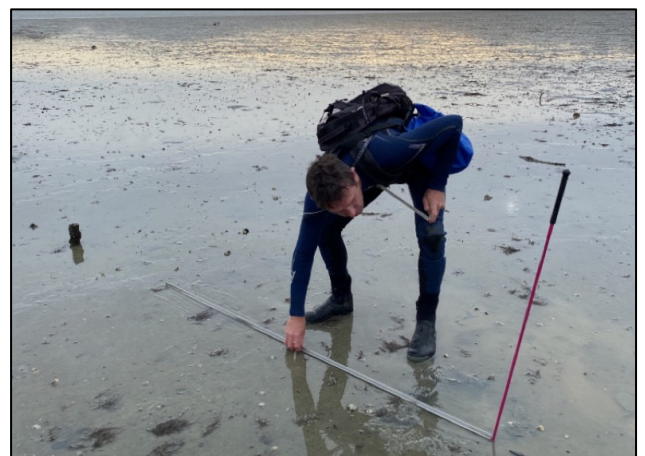
Despite 5-year results showing a net increase in intertidal deposition at the Pāuatahanui intertidal sites, as mentioned above, sediment erosion was evident at intertidal sites P7 and P8 (Kakaho and Horokiri). This was reflected in a continuing decline in the extensive layer of mud that had been deposited at these sites following intensive rain events in 2017, January 2020 and December 2020 (see next section). The deep, soft deposits that occurred following these rain events (see photos opposite) have now been largely remobilised and the sites are becoming firmer and sandier (see lower photo opposite).

Kakaho intertidal site P7 in December 2020 (top) and in January 2023 (bottom), highlighting the significant deposition and subsequent erosion of muds at the site.

More notably, the sediment erosion and decrease in mud content recorded at sites P7/Kakaho and P8/Horokiri in January 2023 represent a visually obvious improvement in intertidal condition. Both these sites, but particularly P7/Kakaho, were significantly impacted by the deposition of a thick slurry of fine sediment covering previously sandy intertidal flats, following several intensive rain events between 2017-2020 (Roberts et al. 2021). For example, at P7/Kakaho, after three consecutive years of sediment deposition from 2019-2021, there was an 11.2mm decrease recorded from December 2020 to January 2022, followed by a further 4.4mm decrease from January 2022 to January 2023. The change reflects an ongoing reduction in the depth of fine sediment deposited at the site, which is also reflected in the sediment mud content which has reduced from 67.3% to 29.2% to 18.7% over the last three monitoring surveys.

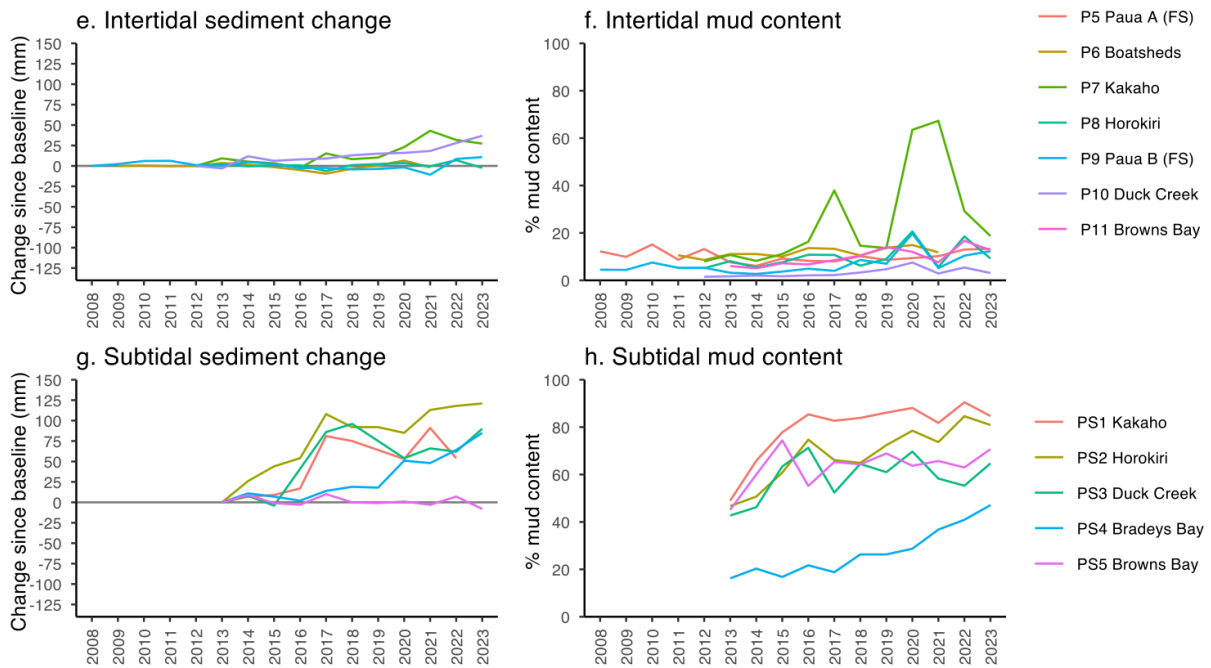
represent the deeper settlement basins of the estuary. Bradeys Bay (PS4), a sandier site, has had a steadily increasing mud content since monitoring began in 2013, likely owing to localised areas of sediment run-off from development in the catchment. There has been a large reduction in seagrass cover at this site over the past two years (authors observation, Roberts et al. 2021). Although it is not possible to determine whether seagrass losses have been directly caused by the measured increases in sediment mud content; a recent study in the estuary (Zabarte-Maeztu et al. 2020) suggests that sediment mud content is a strong controlling factor in seagrass health, with seagrass absent from sites with a mud content >23%. At Bradeys Bay, coincident with the observed seagrass losses, mud content increased from 16% in 2013 to 41% in 2022, and was 47% in 2023.

Fig. 4. Sediment depth change (mm) from baseline (year plates installed) and corresponding change in sediment mud content (%) for intertidal and subtidal sites in the Onepoto Inlet and the Pāuatahanui Inlet.

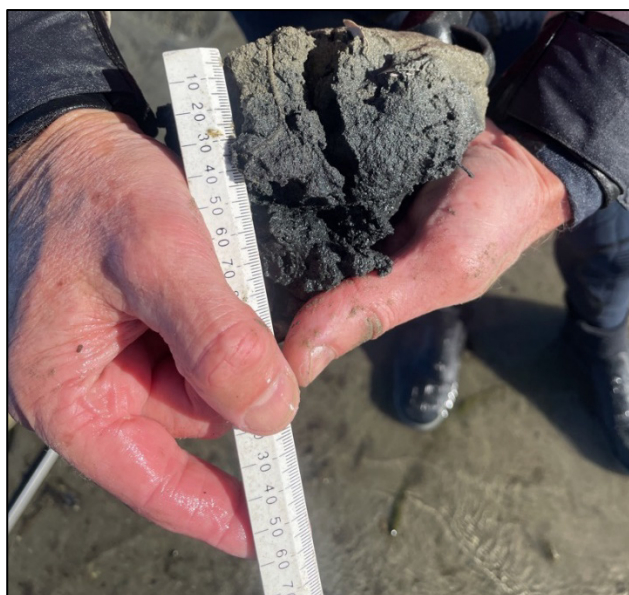
25mm of oxygenated sand above organically enriched sediment Por B (O3), Onepoto Inlet.

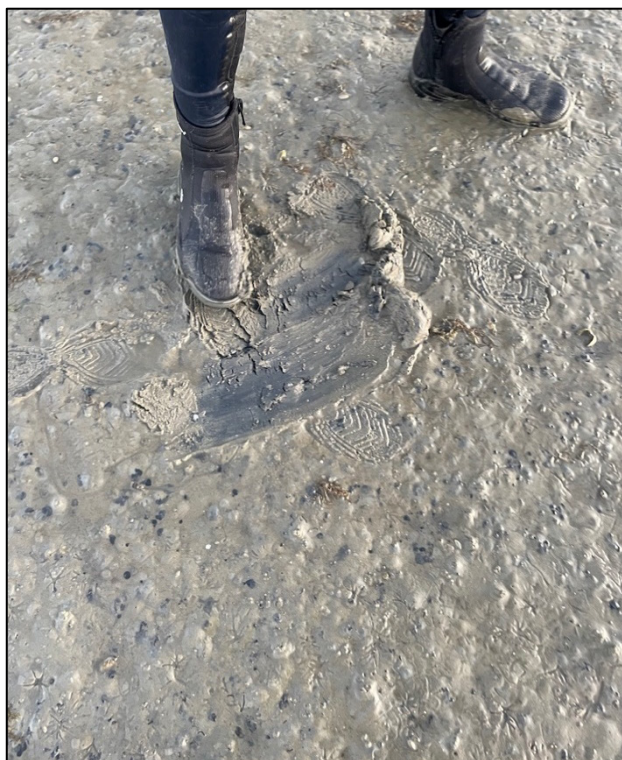
Mud-elevated sediments overlying sandier sediment.

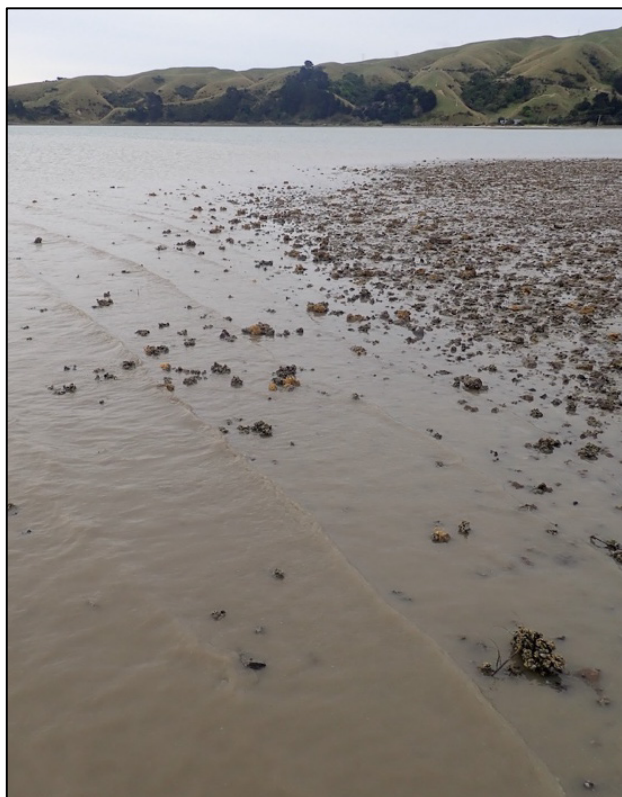
As suggested in previous assessments (e.g., Roberts et al. 2021), wind-driven wave-action appears to be the most likely mechanism for the mobilisation and redistribution of muddy intertidal sediments. While this reduction in intertidal mud cover is encouraging, the changes must be viewed in the context of the whole estuary because any intertidal improvements likely reflect a degradation of subtidal areas. Bathymetric surveys of Te Awarua-o-Porirua Harbour have showed substantial accretion over time (Gibb & Cox 2009, Cox 2015, Waller 2019 - Figs 5 and 7) highlighting the retention of sediment inputs within subtidal harbour areas. Such results, and the 10-year trend at subtidal sedimentation sites (Table 2), indicate that mud mobilised from the intertidal zone is almost certainly being deposited in the deeper subtidal deposition zones of the estuary.

Fine muds in the shallow subtidal margins are readily re-suspended by even small waves, resulting in decreased water clarity and facilitating the redistribution of sediment throughout the harbour.

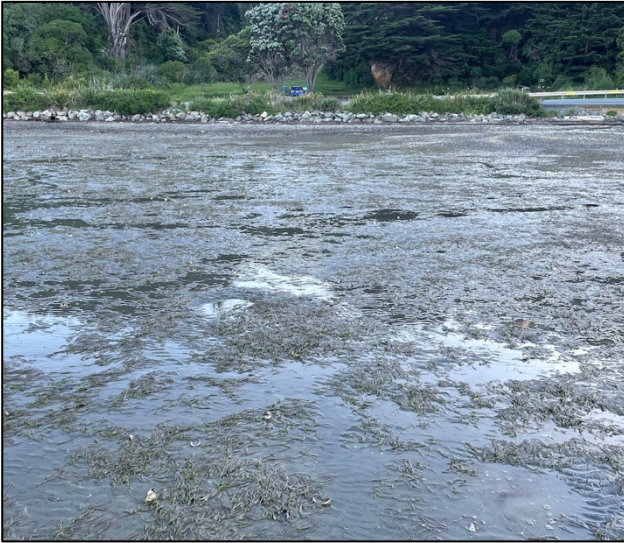
The first is related to the reduction in seagrass previously reported at Bradeys Bay. Although the extent of the loss has not been quantified, it is estimated to be at ~90%. The photo below illustrates that the extensive beds of seagrass that previously had a near complete cover, are now patchy and in decline. Of the remaining seagrass, much of it had thick cover of epiphytic growth in January 2023, which is potentially adversely impacting seagrass condition.

Patchy seagrass remaining in Bradeys Bay, January 2023.

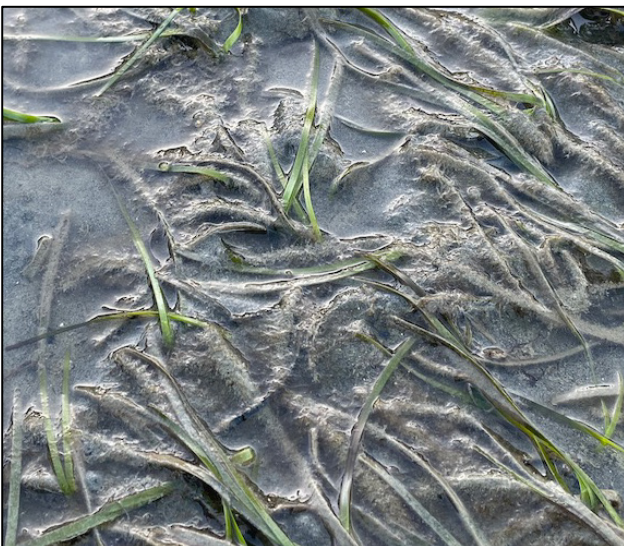
Epiphytic growth on seagrass at Bradeys Bay, January 2023.

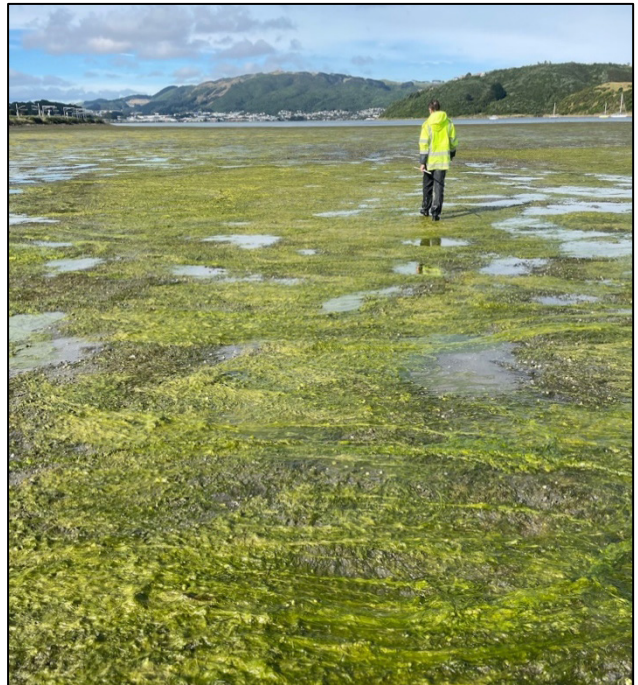
The second observation relates to the presence in 2023 of extensive mats of *Chaetomorpha ligustica* on the Paremata railway flats. Observed previously in 2020, these mats have anecdotally become more conspicuous in recent years (Stevens and Forrest 2020), and appear to be formed by the same species described as being present in Te Awarua-o-Porirua Harbour since the 1950's (Adams 1994). The *Chaetomorpha* mats present in 2023 appeared to mainly be drift (unattached) material, but had smothered cockle beds or killed patches of seagrass beneath them in many localised places.

Mats of *Chaetomorpha ligustica*, Paremata railway flats, January 2023.

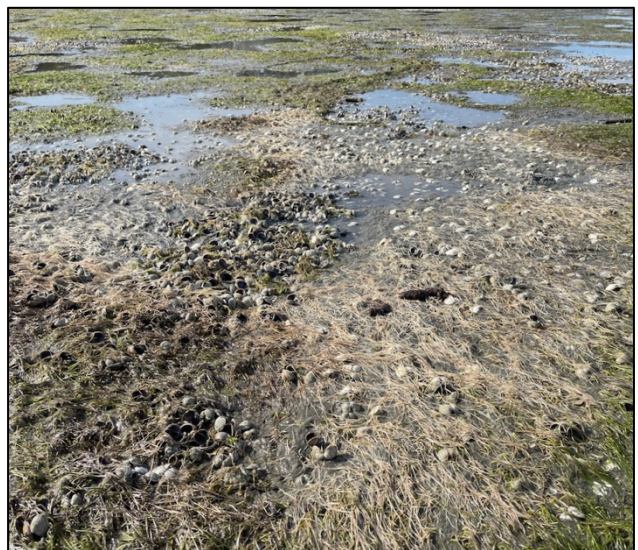
Dead cockles and seagrass caused by mats of *Chaetomorpha ligustica* on the Paremata railway flats, January 2023.
